## Evaluation of the brass CuZn39Pb3 resistance at vibratory cavitation erosion

To cite this article: I Lazar *et al* 2019 *IOP Conf. Ser.: Mater. Sci. Eng.* **477** 012002

I Lazar<sup>1</sup>, I Bordeasu<sup>1</sup>, M O Popoviciu<sup>2</sup>, I Mitelea<sup>1</sup>, C M Craciunescu<sup>1</sup>,  
L D Pirvulescu<sup>1</sup>, M Sava<sup>1</sup> and L M Micu<sup>3</sup>

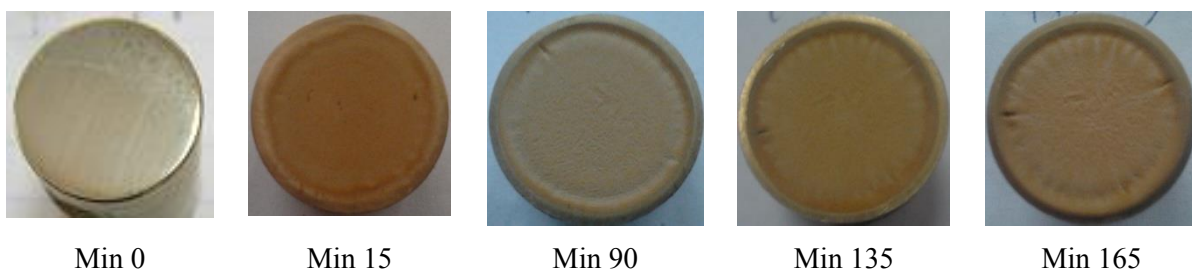
**Figure 5.** Images of specimen surface at different cavitation exposure time

The images of Figure 5 show that in the first 15 minute the cavitation erosion begins with the formation of a peripheral ring. The explanation consists in the imploding mode of the cavitation cloud (see Figure 2) which determines caverns and erosions only in this ring and towards the inner zone of the exposed surface are only eliminated the roughness picks and generated cracks networks without visible caverns. For 90 minutes of cavitation, on the external ring are formed star like caverns and simultaneously on the whole exposed surface are visible pittings. This is clearly seen Figure 6 where are presented photographs obtained with a SEM microscope were it can be seen how the phase  $\beta'$  is expelled and how the cracks are propagated. All this facts determines the increase of the mean depth erosion rate which reached a maximum (see Figure 4).
