The nature of hydrogen-related fracture in X80 pipeline steel with stress concentration

T Homma¹, S Onuki², H Suzuki³ and K Takai³

Abstract. The nature of hydrogen-related fracture in X80 pipeline steel with stress concentration was investigated through observation of fracture modes at hydrogen-related crack initiation sites and crystallographic analysis of fracture surfaces. The fracture modes and crack initiation sites were observed using a field emission scanning electron microscope (FE-SEM). The hydrogen-related crack initiation sites of X80 specimens were quasi-cleavage (QC) fracture at the notch tip. In addition, distributions of plastic strain and principal stress near the notch tip were calculated by finite element method (FEM) analysis. Since maximum plastic strain occurred at the notch tip where the initiation of QC fracture was observed, the main factor causing QC fracture was probably plastic strain. In order to clarify the crystallographic features of hydrogen-related fracture surfaces of X80, a trace analysis of the QC fracture surface was carried out using electron backscatter diffraction patterns (EBSD). Since not all points on the fracture surface were parallel t

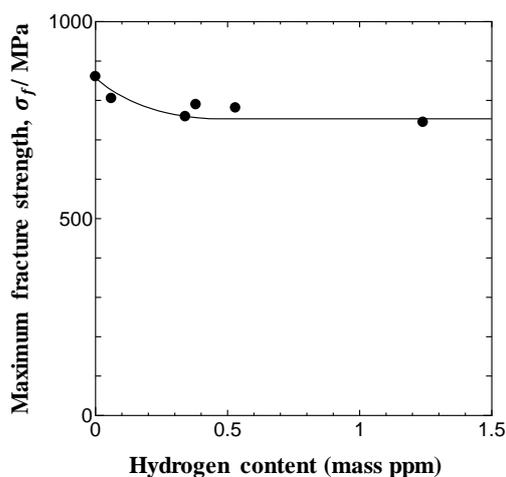
Figure 1. Relationship between maximum fracture strength and hydrogen content.

Figure 1 shows the relationship between the maximum fracture strength and hydrogen content. As the hydrogen content increased, the maximum fracture strength decreased and then became constant. Figure 2 shows the relationship between the maximum fracture strength and the crosshead speed. As the crosshead speed decreased, the maximum fracture strength decreased only for hydrogen-charged specimens, resulting in increased hydrogen embrittlement susceptibility. Possible causes of these results are the hydrogen concentration in a stress concentrated region and the interaction between dislocations and hydrogen. During the tensile test, hydrogen accumulated at the notch tip due to stress-induced diffusion. At a low crosshead speed, hydrogen accumulated sufficiently because there was ample time for it to diffuse [3]. In addition, at a low crosshead speed, hydrogen can move with moving dislocations and the interaction between dislocations and hydrogen is expected to have a large effect [4].

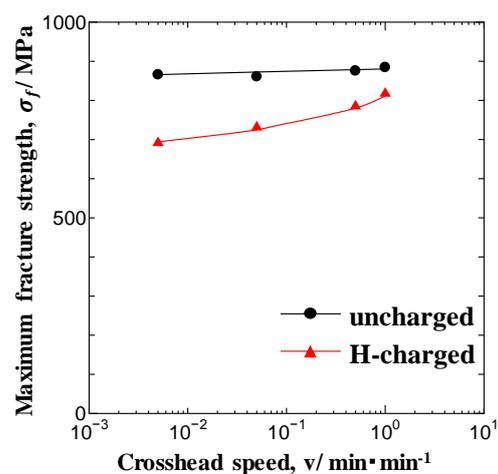
Figure 2. Relationship between maximum fracture strength and crosshead speed.

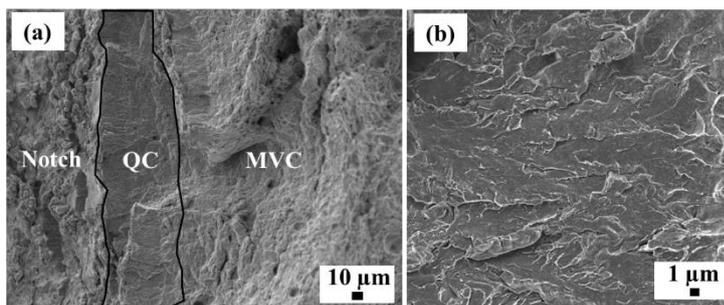
Figure 3. Crack initiation sites of fracture surface at the notch tip in (a) low magnification and (b) high magnification of QC fracture.

Figure 3 shows a photograph of crack initiation sites of a fracture surface at the notch tip of a hydrogen-charged specimen to which the load was applied until just before fracture; the specimen was then dehydrogenated and fractured in the air. Figure 3 (a) shows QC fracture at the notched tip region and microvoid coalescence (MVC) inside specimen. Furthermore, Figure 3 (b) shows QC fracture surface in high magnification. Figure 4 shows the distribution of principal stress and plastic strain at the notch tip obtained by FEM analysis. The plastic strain was maximum at the notch root and the principal stress was maximum at about 0.13 mm away from the notch root. QC fracture is observed in the region from the notch root to about 75 μm away in Figure 3, and this region does not include the maximum principal stress point. Therefore, the main factor causing QC fracture was probably plastic strain.

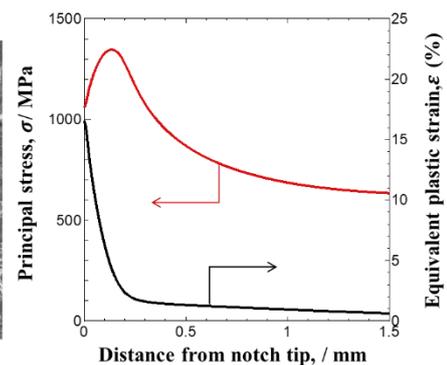
Figure 4. Distribution of principal stress and equivalent plastic strain at the notch tip.

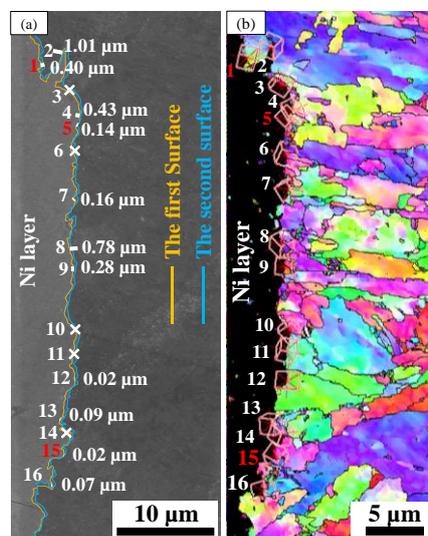
Figure 5. (a) SEM image and (b) EBSD orientation map of quasi-cleavage fracture surface caused by hydrogen.

Figure 5 shows (a) an SEM image and (b) an EBSD orientation map of the QC fracture surface caused by hydrogen. The light gray area in the SEM image and the black area in the EBSD orientation map correspond to the Ni layers. The orange line in the SEM image shows the boundary on the first surface and the blue line shows the boundary on the second surface. The lengths of the white bars show the calculated translation distance values. The traces of $\{011\}$ planes and cubic lattices showing crystal orientation near the fracture surface are indicated by the red lines in the EBSD orientation map. The measurement point numbers parallel to the $\{011\}$ planes are indicated in red, and the measurement point numbers not parallel to the $\{011\}$ planes are indicated in white. The measurement points parallel to the $\{011\}$ planes are 3/16 points. Since not all points on the fracture surface are parallel to $\{011\}$ slip planes, hydrogen-related fracture probably consisted of not only $\{011\}$ slip planes but also various crystal planes due to cross slip in the body-centered cubic lattice.
