## Imaging rover technology: characteristics, possibilities and possible improvements

To cite this article: Valerio Baiocchi *et al* 2018 *J. Phys.: Conf. Ser.* **1110** 012008

Valerio Baiocchi<sup>1</sup>, Chiara Piccaro<sup>1</sup>, Massimo Allegra<sup>2</sup>, Valeria Giammarresi<sup>1</sup>, Felicia Vatore<sup>1</sup>

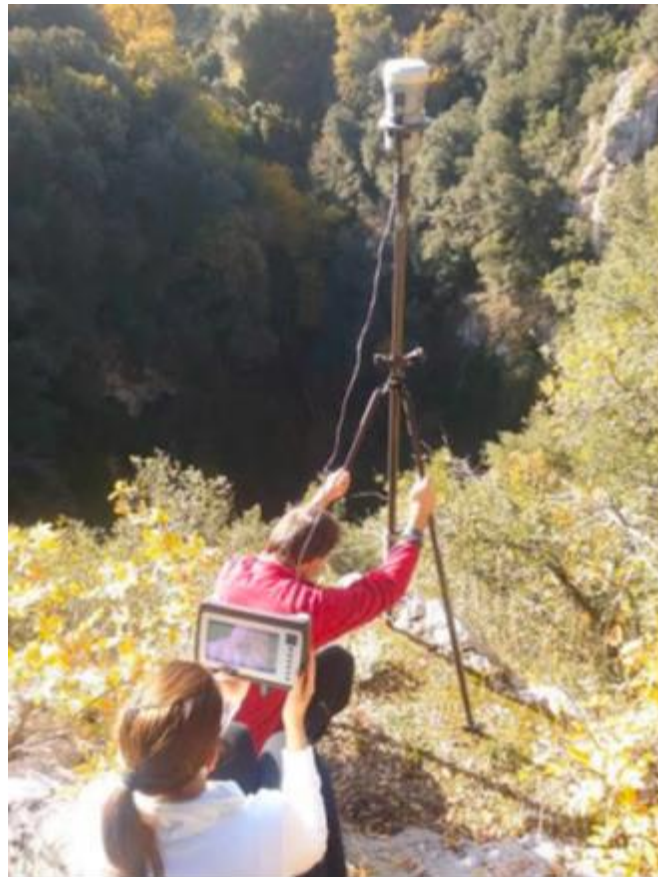
**Figure 1.** The imaging rover combined with GPS/GNSS receiver (on top) during the survey of “Pozzo del Merro”.

The Trimble V10 Imaging Rover (Fig.1) was extensively tested in this experiment. With a total of 12 calibrated cameras, seven panoramic cameras and five cameras oriented downwards, it enables the capture of an entire panoramic image of 60 MP (5 MP per image). These images provide a complete documentation of the site under study, which can then be used for photogrammetric measurements.

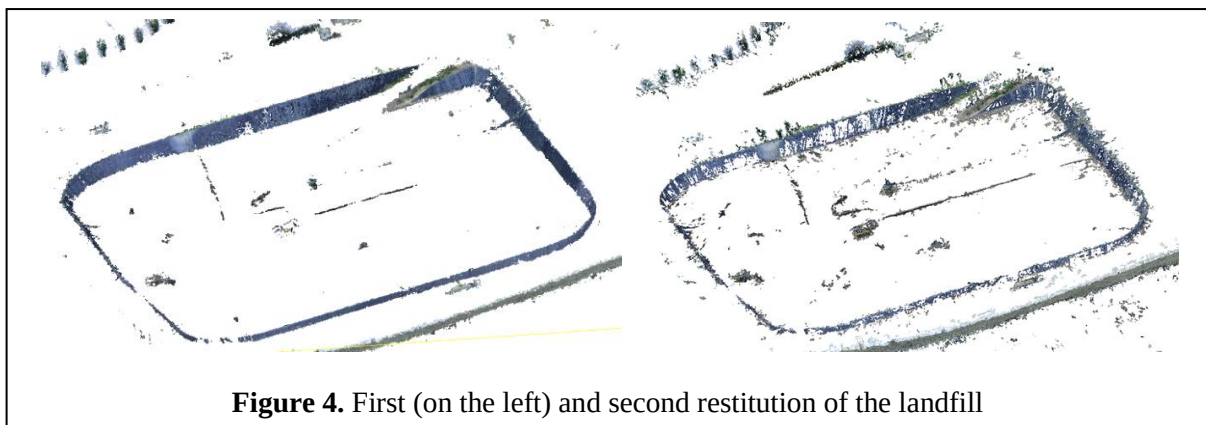
**Figure 4.** First (on the left) and second restitution of the landfill

survey. In this case the results have improved in general, giving more details in the lower part and less details in the upper part (Fig. 4).

For this specific type of survey the result is an improvement as it is not necessary to have a high density of points, due to the irregular characteristics of these surfaces, but it is necessary that the points are evenly distributed throughout the area and the second return is certainly more homogeneous. In this case it can be observed that the statistical parameters between the two tests do not vary significantly (Tab. 2).
