First performance results of the ALICE TPC Readout Control Unit 2

TOPICAL WORKSHOP ON ELECTRONICS FOR PARTICLE PHYSICS 2015, SEPTEMBER 28TH – OCTOBER 2ND, 2015 LISBON, PORTUGAL

ABSTRACT: This paper presents the first performance results of the ALICE TPC Readout Control Unit 2 (RCU2). With the upgraded hardware typology and the new readout scheme in FPGA design, the RCU2 is designed to achieve twice the readout speed of the present Readout Control Unit. Design choices such as using the flash-based Microsemi Smartfusion2 FPGA and applying mitigation techniques in interfaces and FPGA design ensure a high degree of radiation tolerance. This paper presents the system level irradiation test results as well as the first commissioning results of the RCU2. Furthermore, it will be concluded with a discussion of the planned updates in firmware.

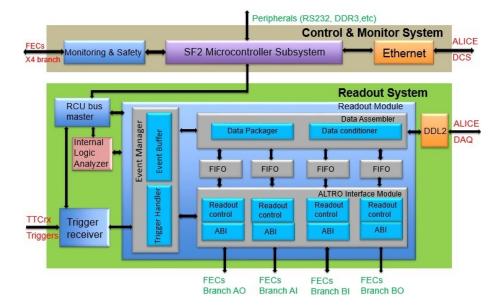
Figure 2. System overview of the RCU2.

As shown in figure 2, the RCU2 consists of two major systems, the Readout System which is implemented in the SF2 FPGA fabric [7] and the Control and Monitor System which runs on the SF2 Microcontroller Subsystem (MSS) [9]. In the Readout System, the Trigger Receiver accepts, decodes and processes the trigger sequence that comes from the ALICE Central Trigger Processor (CTP) [10], before it passes the generated local triggers [11] to the Readout Module. Based on the local trigger information, the Readout Module reads data from the four branches of FECs in parallel, checks its quality, merges and packages it into the format of ALICE data files [12]. At the final stage, the packaged data is pushed into the DDL2 Module [6] through which it is shipped into the ALICE data acquisition system [13]. In addition, an Internal Logic Analyzer, which provides the capability of debugging the internal logics of the Readout System, has been implemented.

The Control and Monitor System includes the Monitoring and Safety Module (MSM) [14], the Ethernet Module and the SF2 MSS with its peripherals. The Monitoring and Safety Module is responsible for monitoring the status of the FECs and reporting it to the ALICE Detector Control System (DCS) [15] in case of abnormal situations. As shown in figure 3, a tailored 32-bit Linux system operates in the ARM-Cortex M3 [9] of the SF2 MSS and three 16-bit DDR3 SDRAMs [16]. Two of the SDRAMs together store the 32-bit words of the Linux, and the third one stores the parity bits used in SECDED mechanism. When SECDED is enabled, the MSS DDR controller [9] computes and adds parity bits to the data while writing into the DDR3 SDRAMs. Then in a read operation, the data and the parity bits are checked to support 1-bit error correction and 2-bit error

detection. The Linux communicates with the Readout System, the Monitoring and Safety Module and the Ethernet Module via a customized APB Bus [9] protocol — the RCU2 Bus. The Ethernet Module, functioning as an interface, bridges the Control and Monitor System to the ALICE DCS.

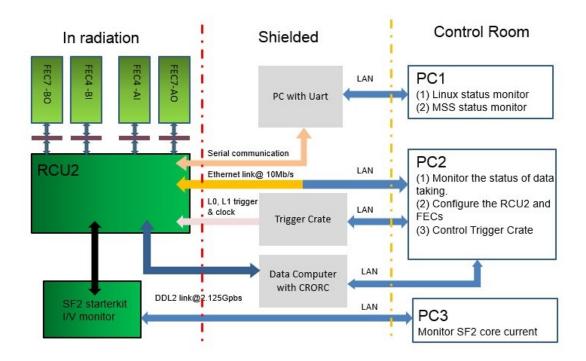
Figure 4. Setup of system level irradiation test at TSL.

In April 2015, a system level irradiation campaign was performed at The Svedberg Laboratory (TSL) in Uppsala using a 170 MeV proton beam. During this campaign the RCU2 was operated in a close to normal running situation while exposed to a wide proton beam at a moderate flux. As shown in figure 4, the test setup consists of three parts.

In the radiation area, the RCU2 is connected to four FECs and the supply voltage and current consumption of the SF2 FPGA is monitored by a SF2 starterkit [17]. The trigger crate, the data computer with the CRORC [6], and the PC which provides serial communication to the RCU2 are located some meters away in a shielded area. Via the LAN, all the above-mentioned devices are controlled and monitored by the three PCs which are located in the control room. In this test, the RCU2 was receiving and processing triggers upon which it was performing the basic data taking operation. At the same time all available registers in the RCU2 were monitored.

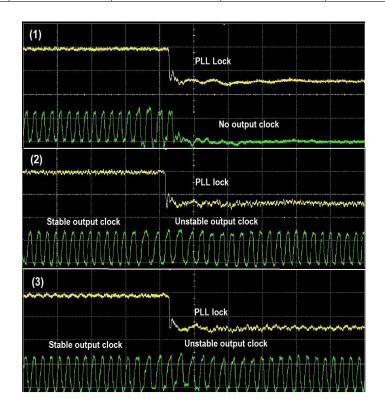
Figure 5. Output clock of PLL with different configuration when it loses lock.

At the time of testing, the PLL lock signal was directly used as a reset signal in RCU2 FPGA design, thus any losses will lead to the stop of data taking. In the SF2, the PLL has three configuration options [9]: (1) holding reset before getting lock, (2) outputting clock before lock and do not synchronize after getting lock, and (3) outputting clock before lock and synchronize after getting lock. According to figure 5, it is concluded that the output clock of the PLL is not reliable

if it loses lock thus its usage should be minimized. There will not be any output clock if the PLL is configured with option (1) and the output clock will be unstable for several clock cycles with option (2) or (3) selected. Following the irradiation campaign, the reset strategy of the RCU2 has been redesigned, where the PLL lock signal is used as a reset signal only when the RCU2 is powered up, and after which it is no longer contributing to the reset scheme.

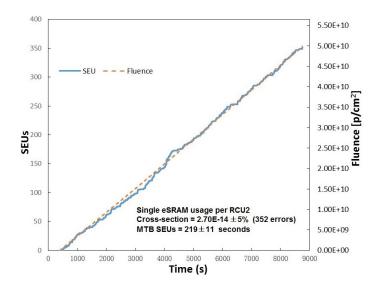
Figure 6. SEUs in SF2 eSRAM

on replacing the Linux system with a real time operation system (RTOS) that only resides on the internal eSRAM in the SF2 is ongoing. As a part of this activity, the cross-section of SEUs in the SF2 eSRAM has been characterized and the mean time between SEUs in RUN2 has been calculated. As shown in figure 6, providing single eSRAM is used on each RCU2, it is expected to see a SEU around every 220 s.

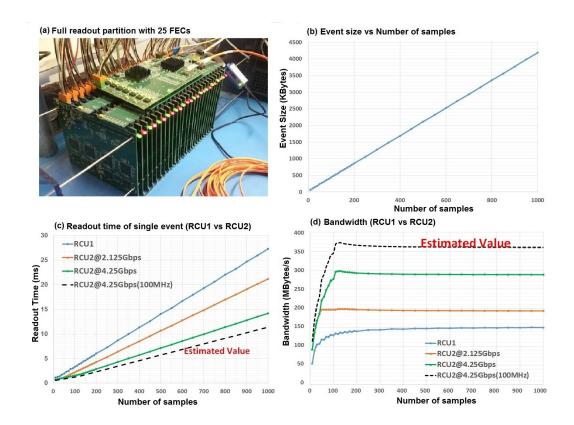
Figure 7. Readout performance benchmarking of the RCU2.

The readout time of single events has been measured in the setup as shown in the subplot (c) of figure 7, where one full readout partition, which consists of one RCU2 and 25 FECs (maximum number), is used. The benchmarking has been performed with full range of readout parameters: the number of data samples in each ALTRO channel [19] was varied from 0 to 1000, with the DDL2 working at 2.125 Gbps and 4.25 Gbps, separately. As presented in the subplot (b) of figure 7, the size of single event is in exact linear proportion to the number of samples, and it is also consistent with that of the events recorded by RCU1 [5].

At the speed of 2.125 Gbps ($\sim 200\,\text{MB/s}$), the DDL2 link starts to get saturated if the number of samples exceeds ~ 50 . In this condition, the readout speed can be improved with a factor of ~ 1.3 with respect to RCU1 [5]. With DDL2 working at 4 Gpbs ($\sim 400\,\text{MB/s}$), the readout speed of the RCU2 can be increased by a factor of ~ 2 compared to the RCU1. In this case, it

is the Readout System operating at $80\,\text{MHz}$ that limits the performance, because it can provide a maximum bandwidth at only $\sim 305\,\text{MB/s}$. A further performance improvement is expected by changing the internal clock frequency from $80\,\text{MHz}$ to $100\,\text{MHz}$. In this case the readout speed is estimated to be ~ 2.6 times that of the RCU1. The $100\,\text{MHz}$ clock source will be provided by an on-board oscillator, thus the usage of PLLs in the SF2 can be fully avoided.
