## Emergency treatment of tailings reservoir leakage pollution in watershed – taking manganese pollution as an example

To cite this article: Sili Chen *et al* 2018 *IOP Conf. Ser.: Earth Environ. Sci.* **199** 022026

Sili Chen, Zhengke Zhang, Sha Chang, Dawei Huang, Licai Hu, Yongxin Bing<sup>a</sup> and Qingwei Guo<sup>a</sup>

South China Institute of Environmental Science, MEP, Guangzhou 510655, China

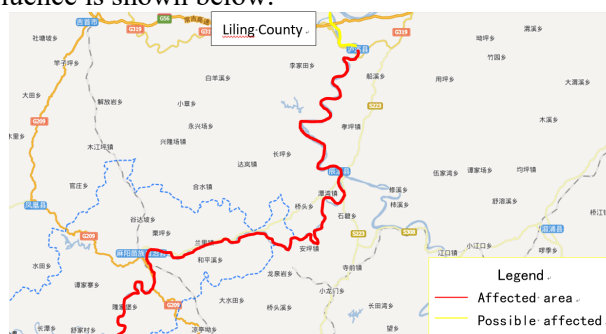
Therefore, the manganese flushed into the river was hundreds of tons, and the polluted section in Guizhou Province was about 30 km. If no effective measures were taken, the discharge of polluted water masses will affect Fuling County, and the affected river sections in Hunan will exceed 200 km. The estimated area of influence is shown below.

Figure 1. Preliminary estimation of affected area

By the time the emergency team arrived, the manganese concentration in the Guizhou-Hunan boundary exceeded limit 30-60 times, and the flow rate of Jinjiang was about 280 m<sup>3</sup>/s. The manganese flushed into the river was 300-400 tons (analyzed in section 2.3). According to the preliminary simulation performed by the emergency team, if no any pollutant reduction measures were taken, the pollutants was diluted by the reservoir water along the existing river channel, the following situation could be predicted: the polluted water masses will approximately arrive Mayang on November 12<sup>th</sup>, arrive Chenxi on November 17<sup>th</sup> (manganese exceed limit 10-20 times), arrive Luxi on November 22<sup>nd</sup> (manganese exceed limit about 5 times). The polluted water masses will eventually arrive Liling on November 30<sup>th</sup>, and the manganese concentration could meet the standard after water dilution from Lishui reservoir. About 200 km of Jingjian River section in Hunan will be affected by this incident. However, if pollutant engineering reduction measures were taken at the river section between Guizhou and Chenxi, the water quality could meet the standard before reaching Luxi County.
